Status of RFQ Injector (PIP)

C.Y. Tan
05 Dec 2012

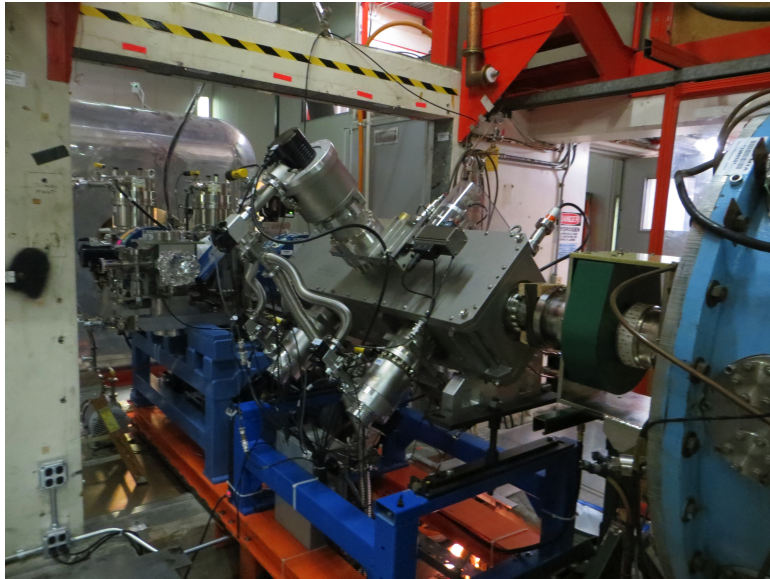
First try: we only got ~20 mA at the exit of the RFQ????

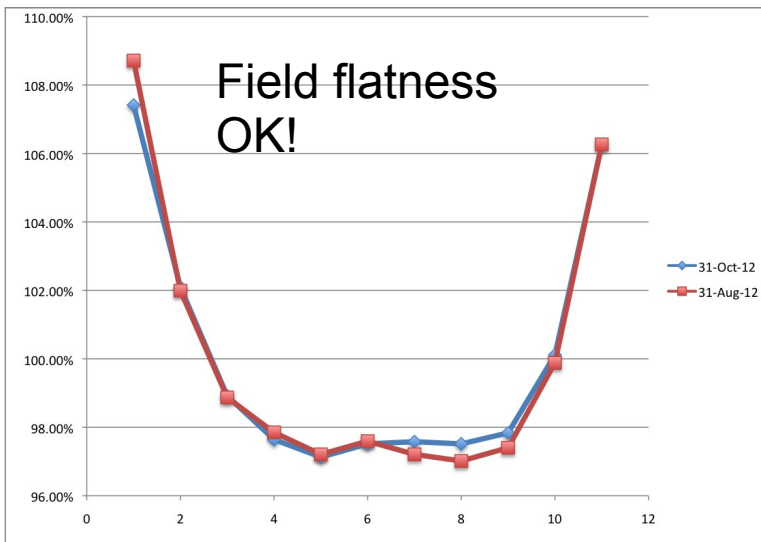
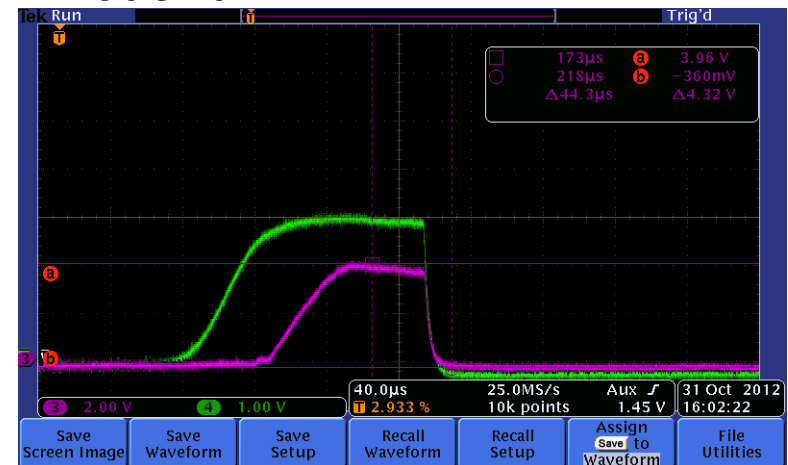
Fixed solenoid PS. Got 43 mA at exit

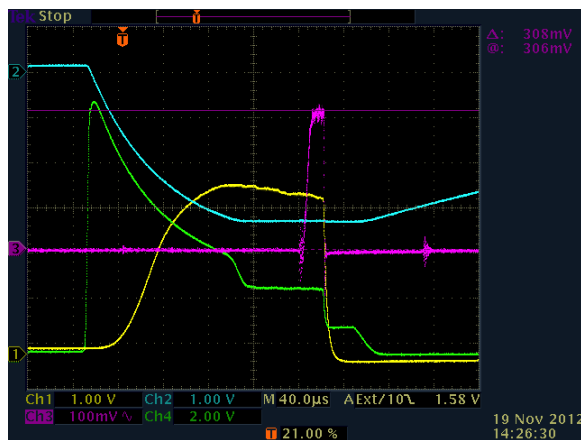
First beam through MEBT and at the beginning of Tank 1!

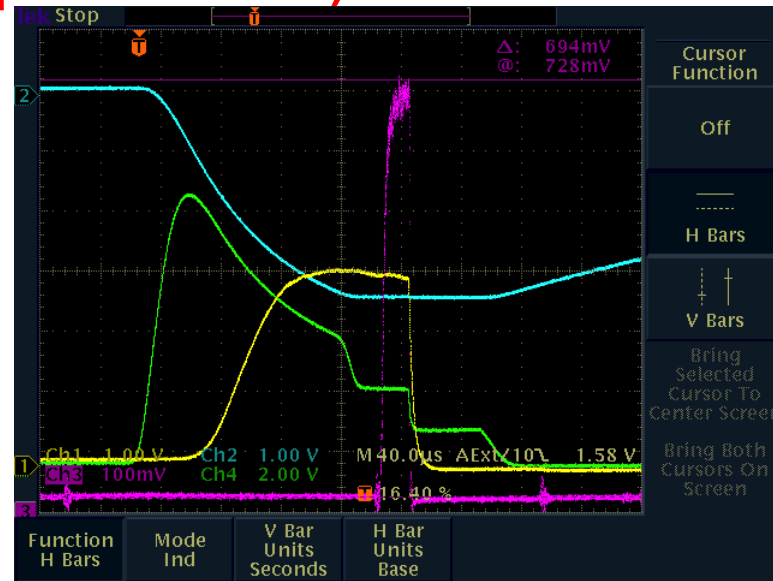
More tuning 14 mA

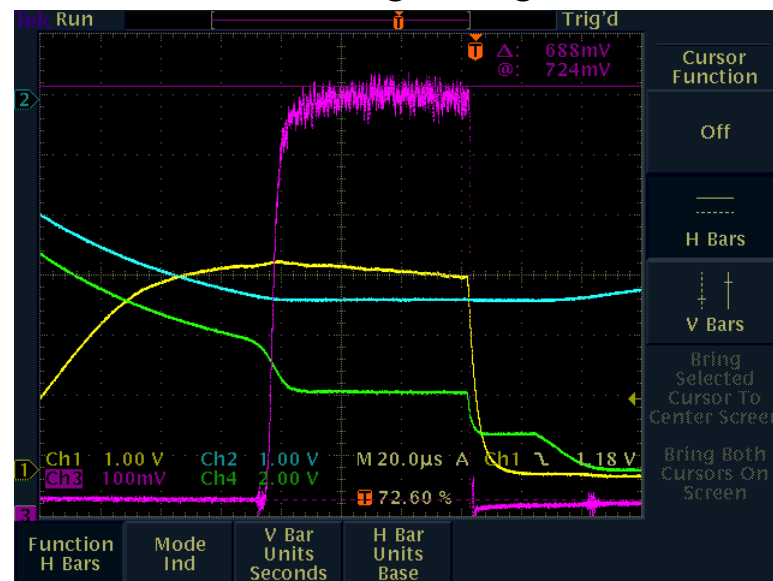
Even more tuning, we get 30 mA

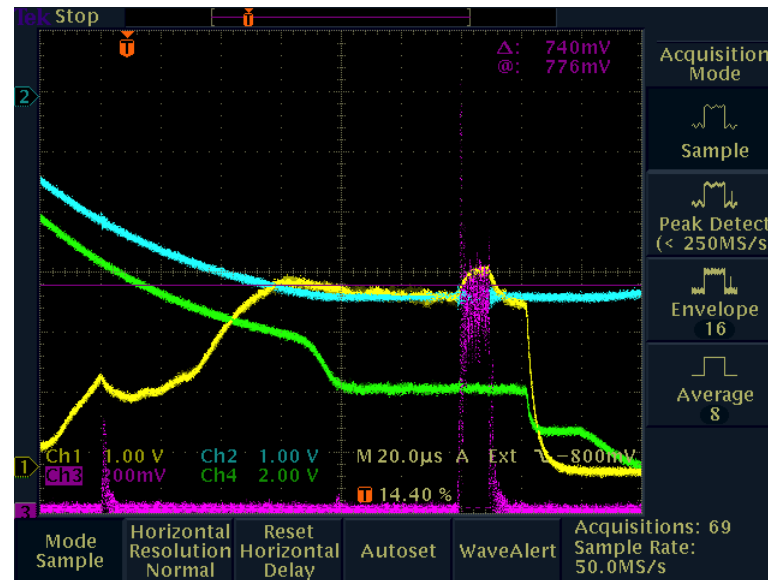
Einzel lens chopper

We get MORE beam with chopper on. 33.6 mA!

Needs more tuning. No tuning since chopping started.

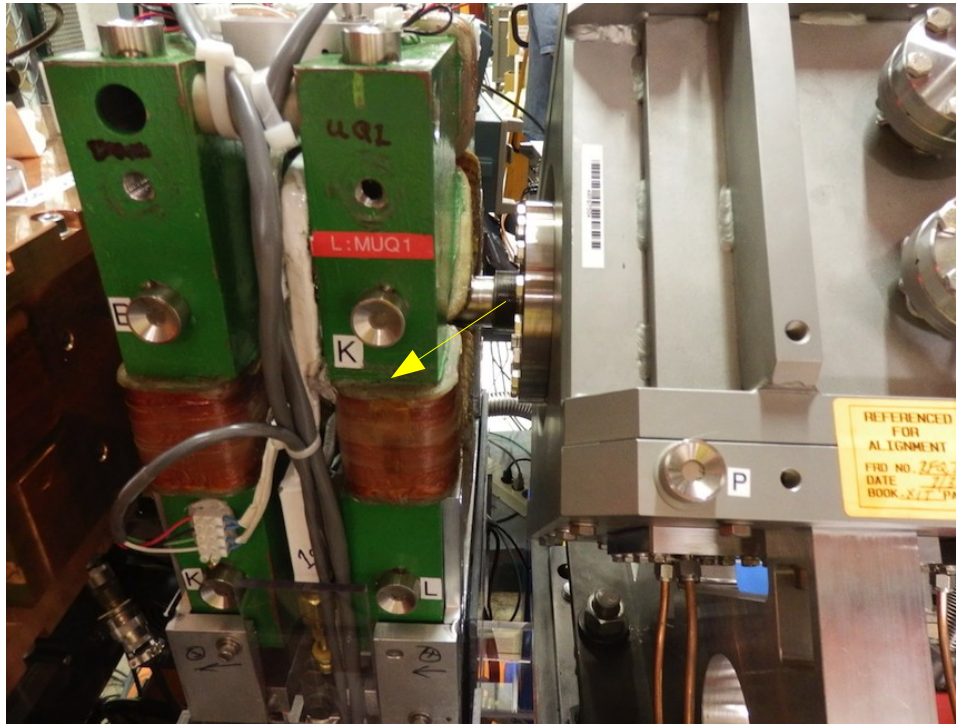
Beam out of RFQ has a large angle!

Angle may be as large as 2 deg!
(mostly vertical)

Indications of the problem is that
the first vertical corrector has to
run VERY HARD ~ 2.5 A.
Emittance probes show this angle.
Downstream quads deflect beam
vertically.

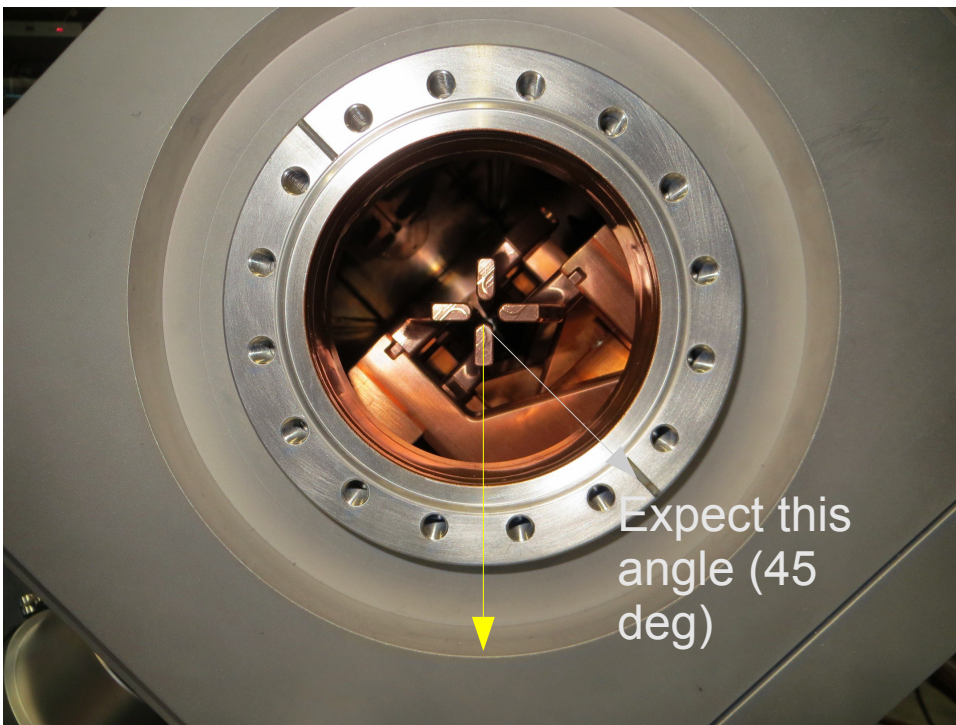
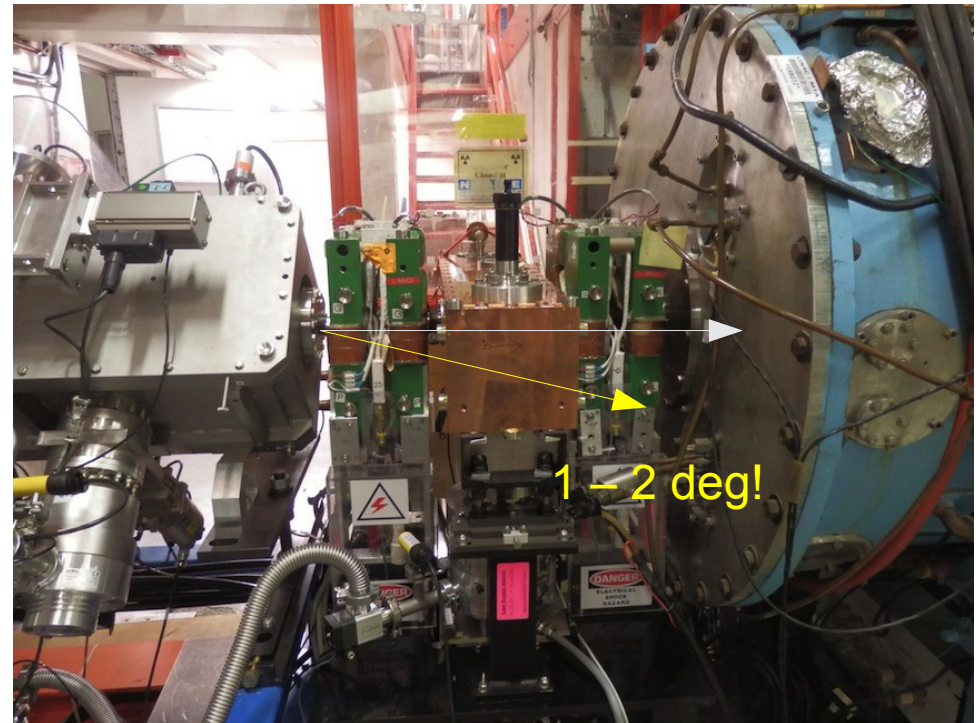
Approximate beam trajectory out of RFQ

Initial measurements with emittance probes show 1 – 2 deg angle out of the RFQ. More machine studies to confirm.

From the asymmetry of the RFQ mounting, I would have expected a 45 deg azimuthal angle and not vertically down. **However, this is PRELIMINARY and subject to change!**

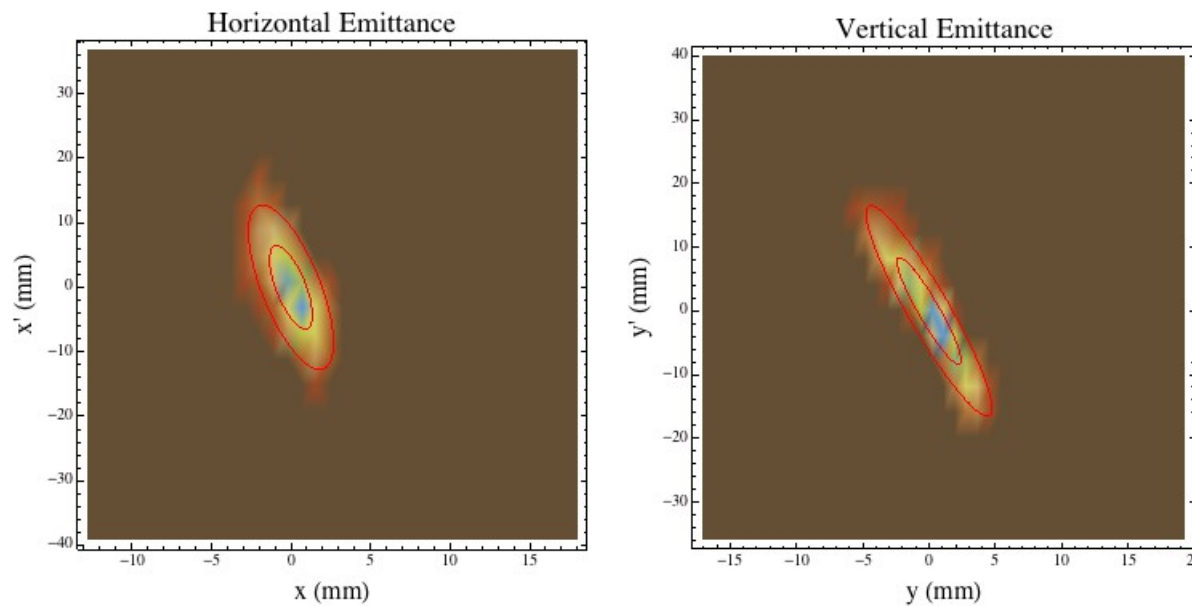
RFQ beam at start of
Tank 1.

$\epsilon_x = 0.26\pi$ mm mrad
 $\epsilon_y = 0.31\pi$ mm mrad
@ 30 mA at Tank 1
